Manhole Inspection Summary

Manhole # S25C1_015MH

Location Address: **2715 MAISEL ST.**

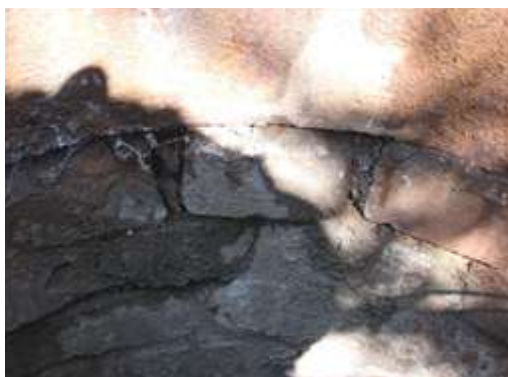
Defect 4

Infiltration: ☐ None ☐ Joint ☐ Cracks ☒ Mortar ☐ Roots ☐ Wall

EVIDENCE OF CHIMNEY
INFILTRATION, MISSING MORTAR

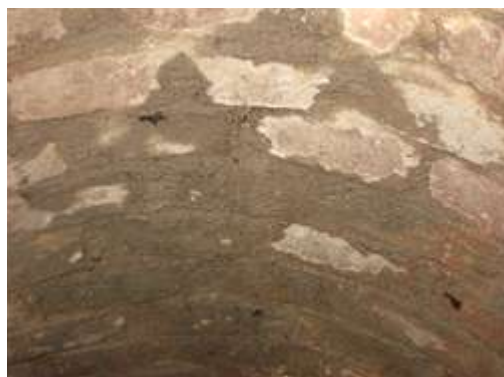
Defect 3

Infiltration: ☐ None ☐ Joint ☐ Cracks ☒ Mortar ☐ Roots ☒ Wall

EVIDENCE OF CORBEL INFILTRATION
AT MORTAR/WALL

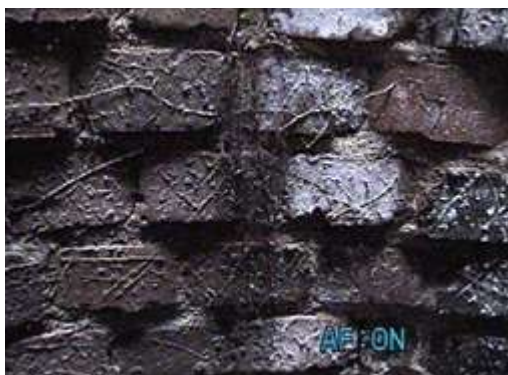
Defect 2

Condition: ☐ Sound ☐ Cracked ☒ Root Intrusion ☐ Loose Brick ☐ Deteriorated

EVIDENCE OF ROOT INTRUSION AT
THE BARREL

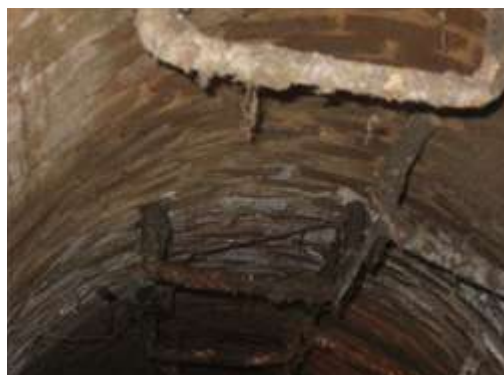
Defect 1

Steps Count: **8** Missing: **0** ☒ Corroded

Surcharge ☒ Evidence Of Surcharge Depth: **6** (ft.) ☐ Active Surcharge Present

EVIDENCE OF SURCHARGE, STEPS
CORRODED

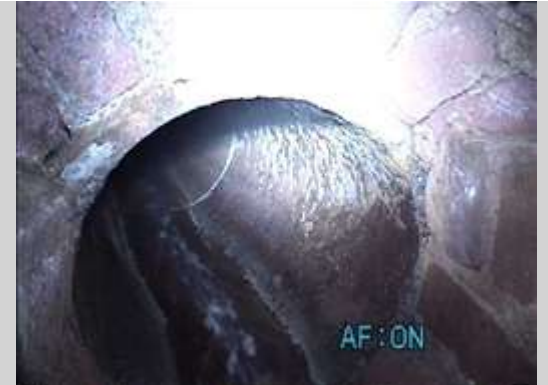
12 O'Clock Outflow

12 in. Circular Gravity Sewer
Pipe Out @ 12 O'Clock

Pipe Height: **9.6** (in.) Rod and Bar (Angled)
Pipe Material: **Clay** ☐ Pipe Lined
Invert Depth: **15.11** (ft.) Flow Characteristics: **Slow**
Deposits: ☒ None ☐ Mud ☐ Sludge ☐ Debris ☐ Grease
Silt Depth: **0** (in.) Deposits Extent:
Infiltration: **None** Pipe Seal Cond: **Sound**

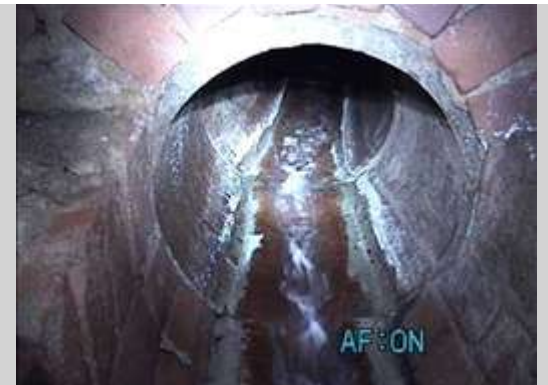
9 O'Clock Inflow

12 in. Circular Gravity Sewer
Pipe In @ 9 O'Clock

Pipe Height: **12** (in.) Rod and Bar (Angled)
Pipe Material: **Clay** ☐ Pipe Lined
Invert Depth: **15.30** (ft.) Flow Characteristics: **None**
Deposits: ☒ None ☐ Mud ☐ Sludge ☐ Debris ☐ Grease
Silt Depth: **0** (in.) Deposits Extent:
Infiltration: **None** Pipe Seal Cond: **Sound**
